September 2014

THE CASE OF THE IMPRUDENT WADERS: JPL BLDG. 277 WATER INCIDENT

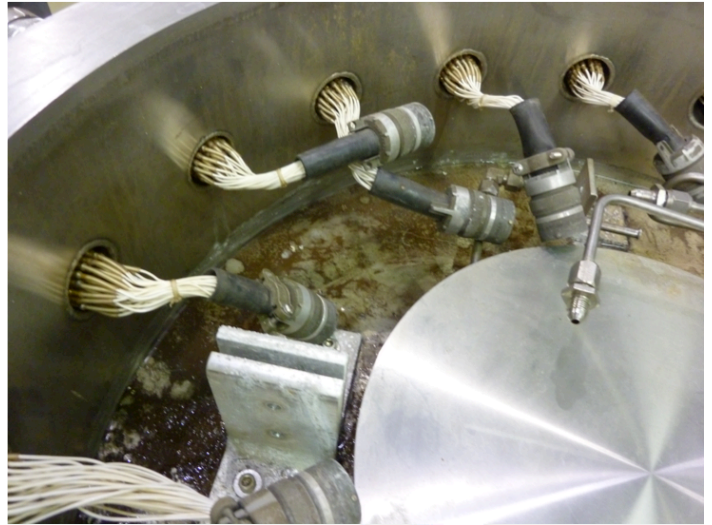
The annual preventative maintenance of the Building 277 water chiller (cooling tower) was performed on February 1, 2014 (References (1) and (2)). This activity involved the removal of autumn leaves and other routine maintenance. As it was a Saturday when most facility staff would be absent, it was a convenient time for the JPL M&O contractor to shut down the chiller, pump, and chilled water that service the TCTTL. However, this work was not coordinated with the building coordinator or with the technicians in the TCTTL lab, and critical testing equipment was not safeguarded or taken off line. The lack of chilled water caused elevated temperatures in the lab's test chambers, resulting in the failure of a brazed joint in Test Chamber #41's closed-loop water cooling system. When their work was completed on Saturday afternoon, the maintenance crew restored the flow to the building's chilled water system. Because the brazed joint cracked due to the high temperature, the chilled water leaked through the crack and entered into the test sample areas of Test Chamber #41. This caused a loss of pressure in the chamber that allowed the water to leak out of the chamber and onto the facility floor.

Close-up of Test Chamber #41 showing the remaining water pooled in the chamber

immersion in the leaked water quenched the samples. The quenching caused the early termination of the life test and loss of all test samples. The purpose of the life test was chiefly to better quantify changes in thermoelectric properties over time at high temperatures to predict degradation of Multi-Mission Radioisotope Thermoelectric Generator (MMRTG) power output.

- Repair the damaged equipment (heaters, ion gauge tube, convection gauge tube, thermocouples, vacuum gauge readout, heat exchanger)
- Conduct safety training
- Develop a contingency plan for lab safety
- Improve coordination with JPL Facilities and the M&O contractor
 - Communication prior to work start
 - Plan actions to take in response to an alarm
 - Plan actions to take in response to an incident

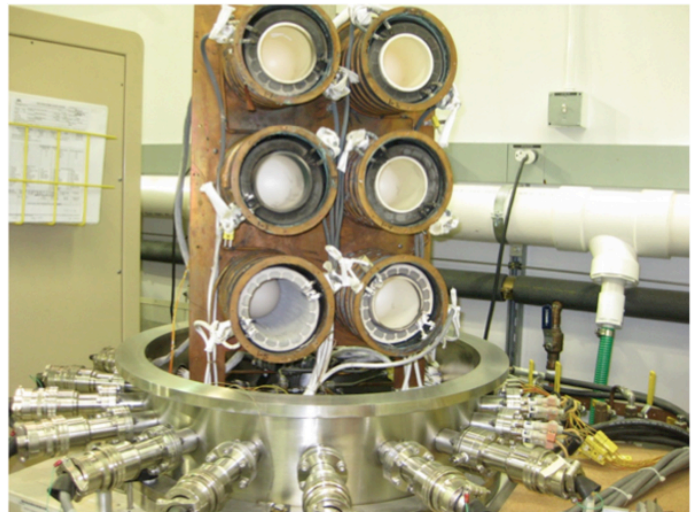
At the time of the water leak, the life test on 18 tellurium, antimony, germanium, and silver material samples had been running continuously in Test Chamber #41 since June 2012, and 16,000 test hours had been accumulated on the samples. The samples were being tested in six separate furnaces, and

Furnaces installed inside a test chamber, which operates in an argon atmosphere

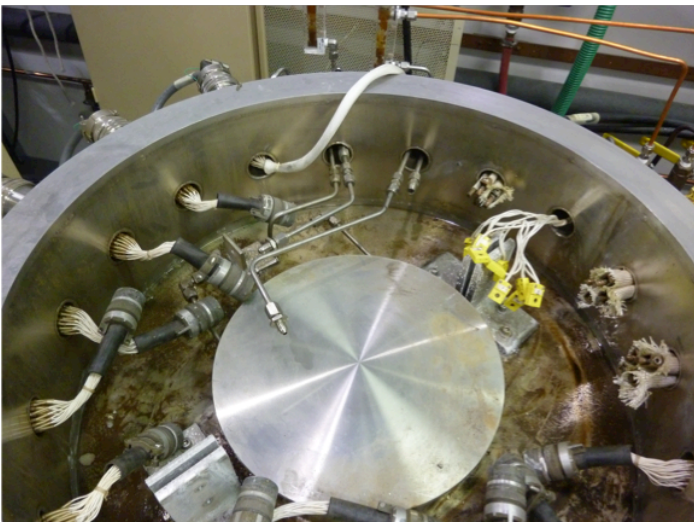
Test Chamber #41 with the top/cover removed.

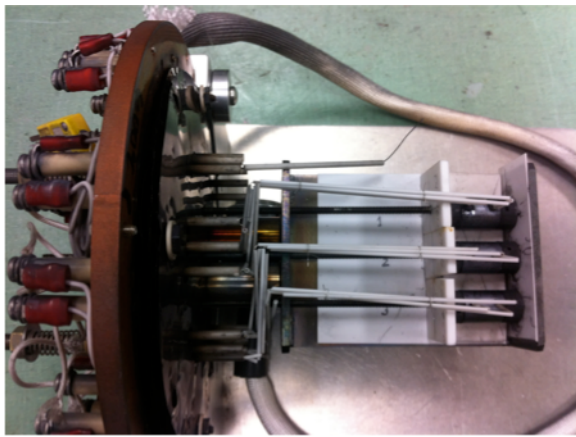
Instrumented test samples mounted on the furnace doors/covers
